TBPOC CONFERENCE CALL April 9, 2013, 5:00pm - 6:00pm

San Francisco-Oakland Bay Bridge Updates

Item- Status Update on Anchor Rods

Slide Presentation - BATA Version

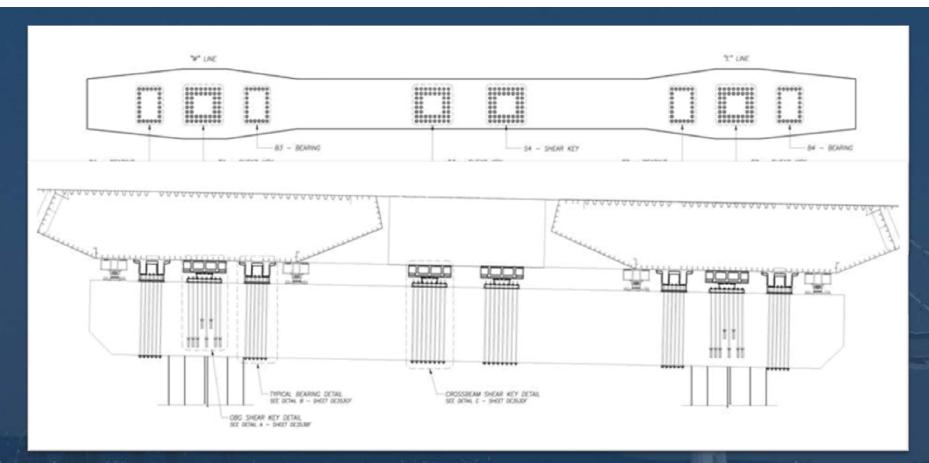
Bearings and shear keys are secured to E2 by 3 inch diameter anchor rods, ranging from 9 feet to 24 feet in length

Each bearing has 24 anchor rods and each shear key has 48 anchor rods for a total of 288 anchor rods

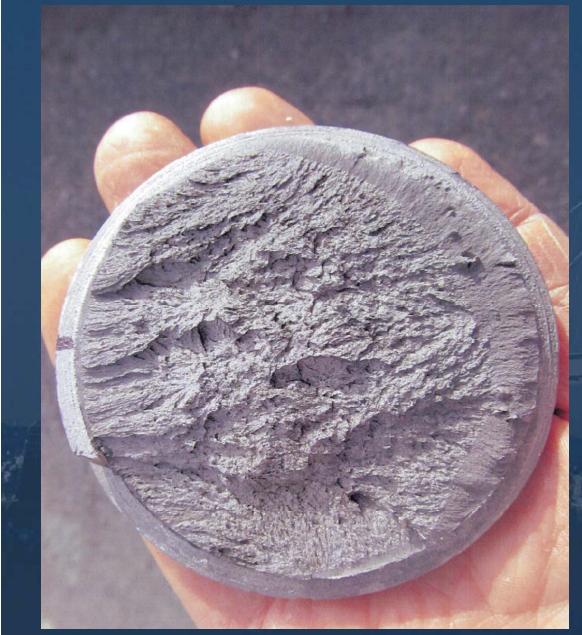
One fractured rod sent to lab for testing

Testing included electron microscopy and mechanical property tests

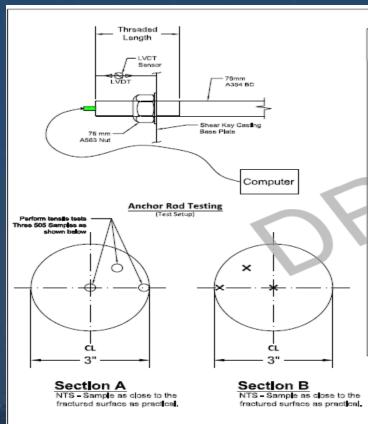
Revision No:	Bys	Date:	SELF-ANCHORED SUSPENSION BRIDGE					
				E2 Bearings & Shear Keys - Testing Protocol					
				L2 Dearings & Official Neys - Tesquig Protocol					
				Drawn By:	BD	011555			
				Date:	4/1/2013	SHEET NUMBER	SK-01		
						NOMBER

Bay Bridge Anchor Rod Testing (192 Rods)

- 1. In-Situ testing shall be performed on all 192 anchor rods as described below
- 2. Select 10 different rods for extended testing. 10 rod sample size (~ 5%) is larger than ASTM F1470 requirements of 7 bars for lot size of 151 to 280 rods.

In-Situ Testing Protocol:

- 1. Mark the rods selected for extended testing to identify the jacking end.
- 2. Install acoustic measuring devices on each of the 10 sample rods selected for extended testing.
- 3. Load all 192 rads up to 0.75Fu (with seating loss expected to bring the final tension in the rads down to the Design load of
- 4. Maintain the applied load for 30 days, during which all rods will be visually inspected daily, checking for failures.
- 5. METS will manitor the acoustic measuring output on the 10 rads selected for the extended testing
- 6. If any rod (of the total lot of 192 rods) fails prior to the 30 day testing period, extract and perform post fracture analysis as detailed below under "Extended Testing Protocol".
- If no rods fail within the 30 day period, extract the 10 sample rods, transport to a testing facility/load bed.

- Extended Testing Protocol.
 (Tests listed below to be performed at an independent testing laboratory accredited per ISO 17025 or approved by Caltrans).

- 1. Load the 10 samples to failure. The rods shall be jacked at the same ends as they were jacked during the in-situ testing.
- Perform Charpy V-Notch testing of broken rods at room temperature and at 40 degrees F.

- 3. Perform reduced section tensile tests (.505 diameter) of the broken rods as close to the fracture surface as possible. Tensile tests to be performed as detailed in Section A.

- 4. Perform hardness Testing (Rockwell C and Knoop Micro-hardness) of broken rods.
- 5. Perform chemical analysis of broken rods at the threaded area and at the shank. Chemical tests to be performed as detailed in

- 6. Perform scanning electron microscopy examination of fracture features on broken rods.
- 7. Perform Micro-structural examination of broken rods at the threaded area.

Note: It is expected that loading of the 192 bolts for 30 days will allow any existing hydrogen atoms to propagate in between the grain boundaries of the steel. Therefore, even if the bolts do not fail within the 30 day period, the scanning electron microscopy will provide sufficient information necessary to determine presence of Hydrogen.

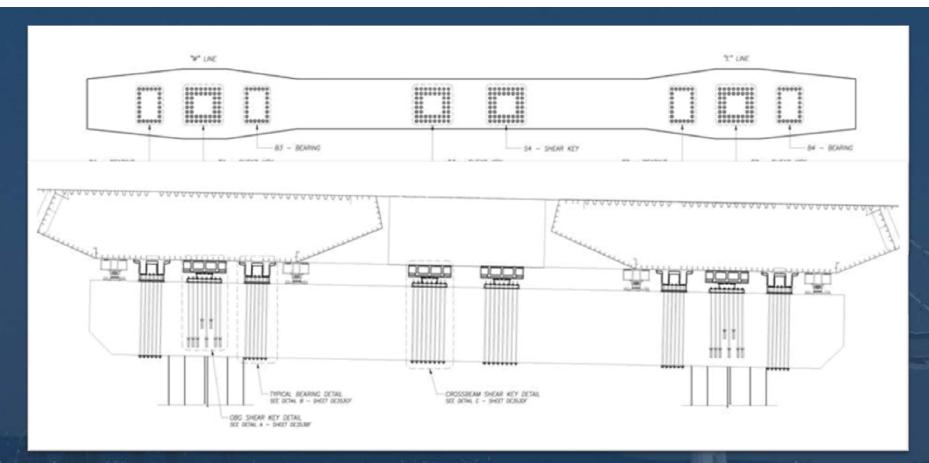
Bearings and shear keys are secured to E2 by 3 inch diameter anchor rods, ranging from 9 feet to 24 feet in length

Each bearing has 24 anchor rods and each shear key has 48 anchor rods for a total of 288 anchor rods

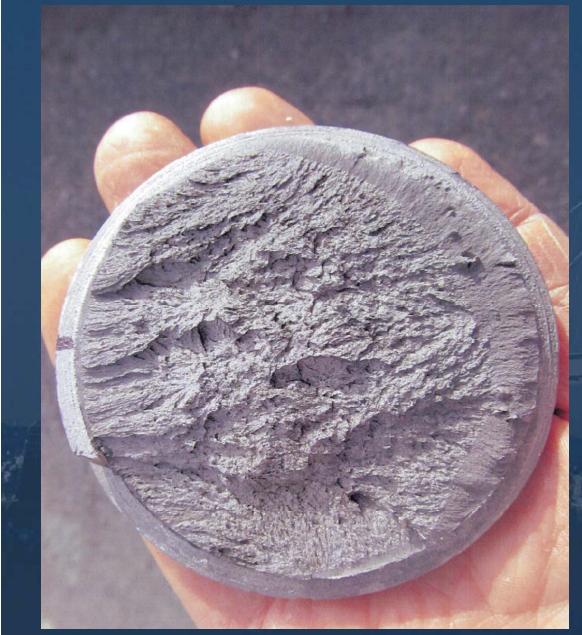
One fractured rod sent to lab for testing

Testing included electron microscopy and mechanical property tests

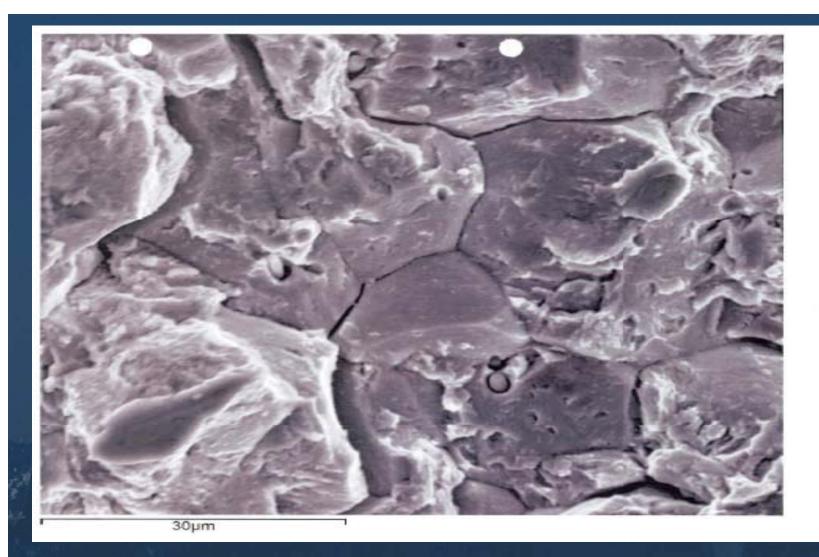
SEM 2

1000X Magnification From "crescent moon": area of sample

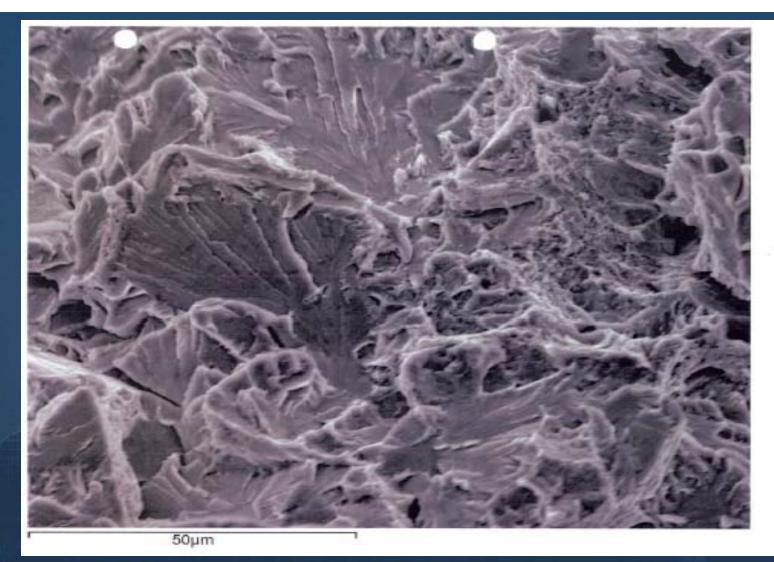
SEM 5

1000X Magnification From interior area of sample (center of rod)

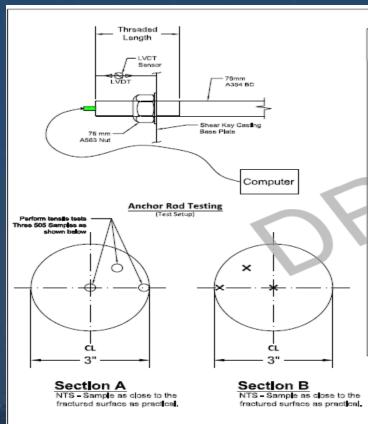
Revision No:	Bys	Date:	SELF-ANCHORED SUSPENSION BRIDGE			
				E2 Bearings & Shear Keys - Testing Protocol			
				Drawn By:	BD	011555	
				Date:	4/1/2013	SHEET NUMBER	SK-01

Bay Bridge Anchor Rod Testing (192 Rods)

- 1. In-Situ testing shall be performed on all 192 anchor rods as described below
- 2. Select 10 different rods for extended testing. 10 rod sample size (~ 5%) is larger than ASTM F1470 requirements of 7 bars for lot size of 151 to 280 rods.

In-Situ Testing Protocol:

- 1. Mark the rods selected for extended testing to identify the jacking end.
- 2. Install acoustic measuring devices on each of the 10 sample rods selected for extended testing.
- 3. Load all 192 rads up to 0.75Fu (with seating loss expected to bring the final tension in the rads down to the Design load of
- 4. Maintain the applied load for 30 days, during which all rods will be visually inspected daily, checking for failures.
- 5. METS will manitor the acoustic measuring output on the 10 rads selected for the extended testing
- 6. If any rod (of the total lot of 192 rods) fails prior to the 30 day testing period, extract and perform post fracture analysis as detailed below under "Extended Testing Protocol".
- If no rods fail within the 30 day period, extract the 10 sample rods, transport to a testing facility/load bed.

- Extended Testing Protocol.
 (Tests listed below to be performed at an independent testing laboratory accredited per ISO 17025 or approved by Caltrans).

- 1. Load the 10 samples to failure. The rods shall be jacked at the same ends as they were jacked during the in-situ testing.
- Perform Charpy V-Notch testing of broken rods at room temperature and at 40 degrees F.

- 3. Perform reduced section tensile tests (.505 diameter) of the broken rods as close to the fracture surface as possible. Tensile tests to be performed as detailed in Section A.

- 4. Perform hardness Testing (Rockwell C and Knoop Micro-hardness) of broken rods.
- 5. Perform chemical analysis of broken rods at the threaded area and at the shank. Chemical tests to be performed as detailed in

- 6. Perform scanning electron microscopy examination of fracture features on broken rods.
- 7. Perform Micro-structural examination of broken rods at the threaded area.

Note: It is expected that loading of the 192 bolts for 30 days will allow any existing hydrogen atoms to propagate in between the grain boundaries of the steel. Therefore, even if the bolts do not fail within the 30 day period, the scanning electron microscopy will provide sufficient information necessary to determine presence of Hydrogen.

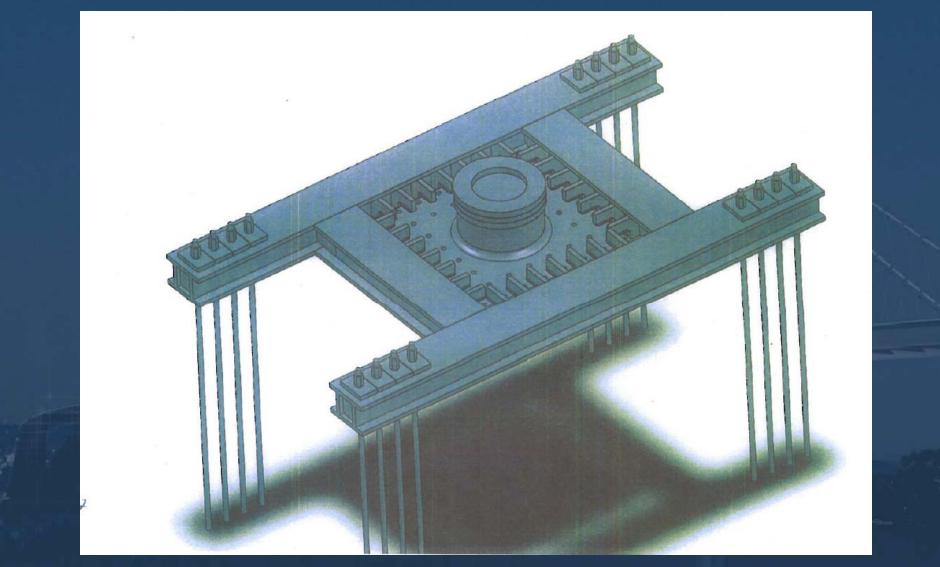
Conceptual design – steel collar
